Report of Structural Inspection and Condition Assessment of Trimming Room - Areas 2 & 3 and Press Room - Area 12 at the Former Bossert Manufacturing Facility

Utica, New York

November 14, 1997

Project No. 24708.01

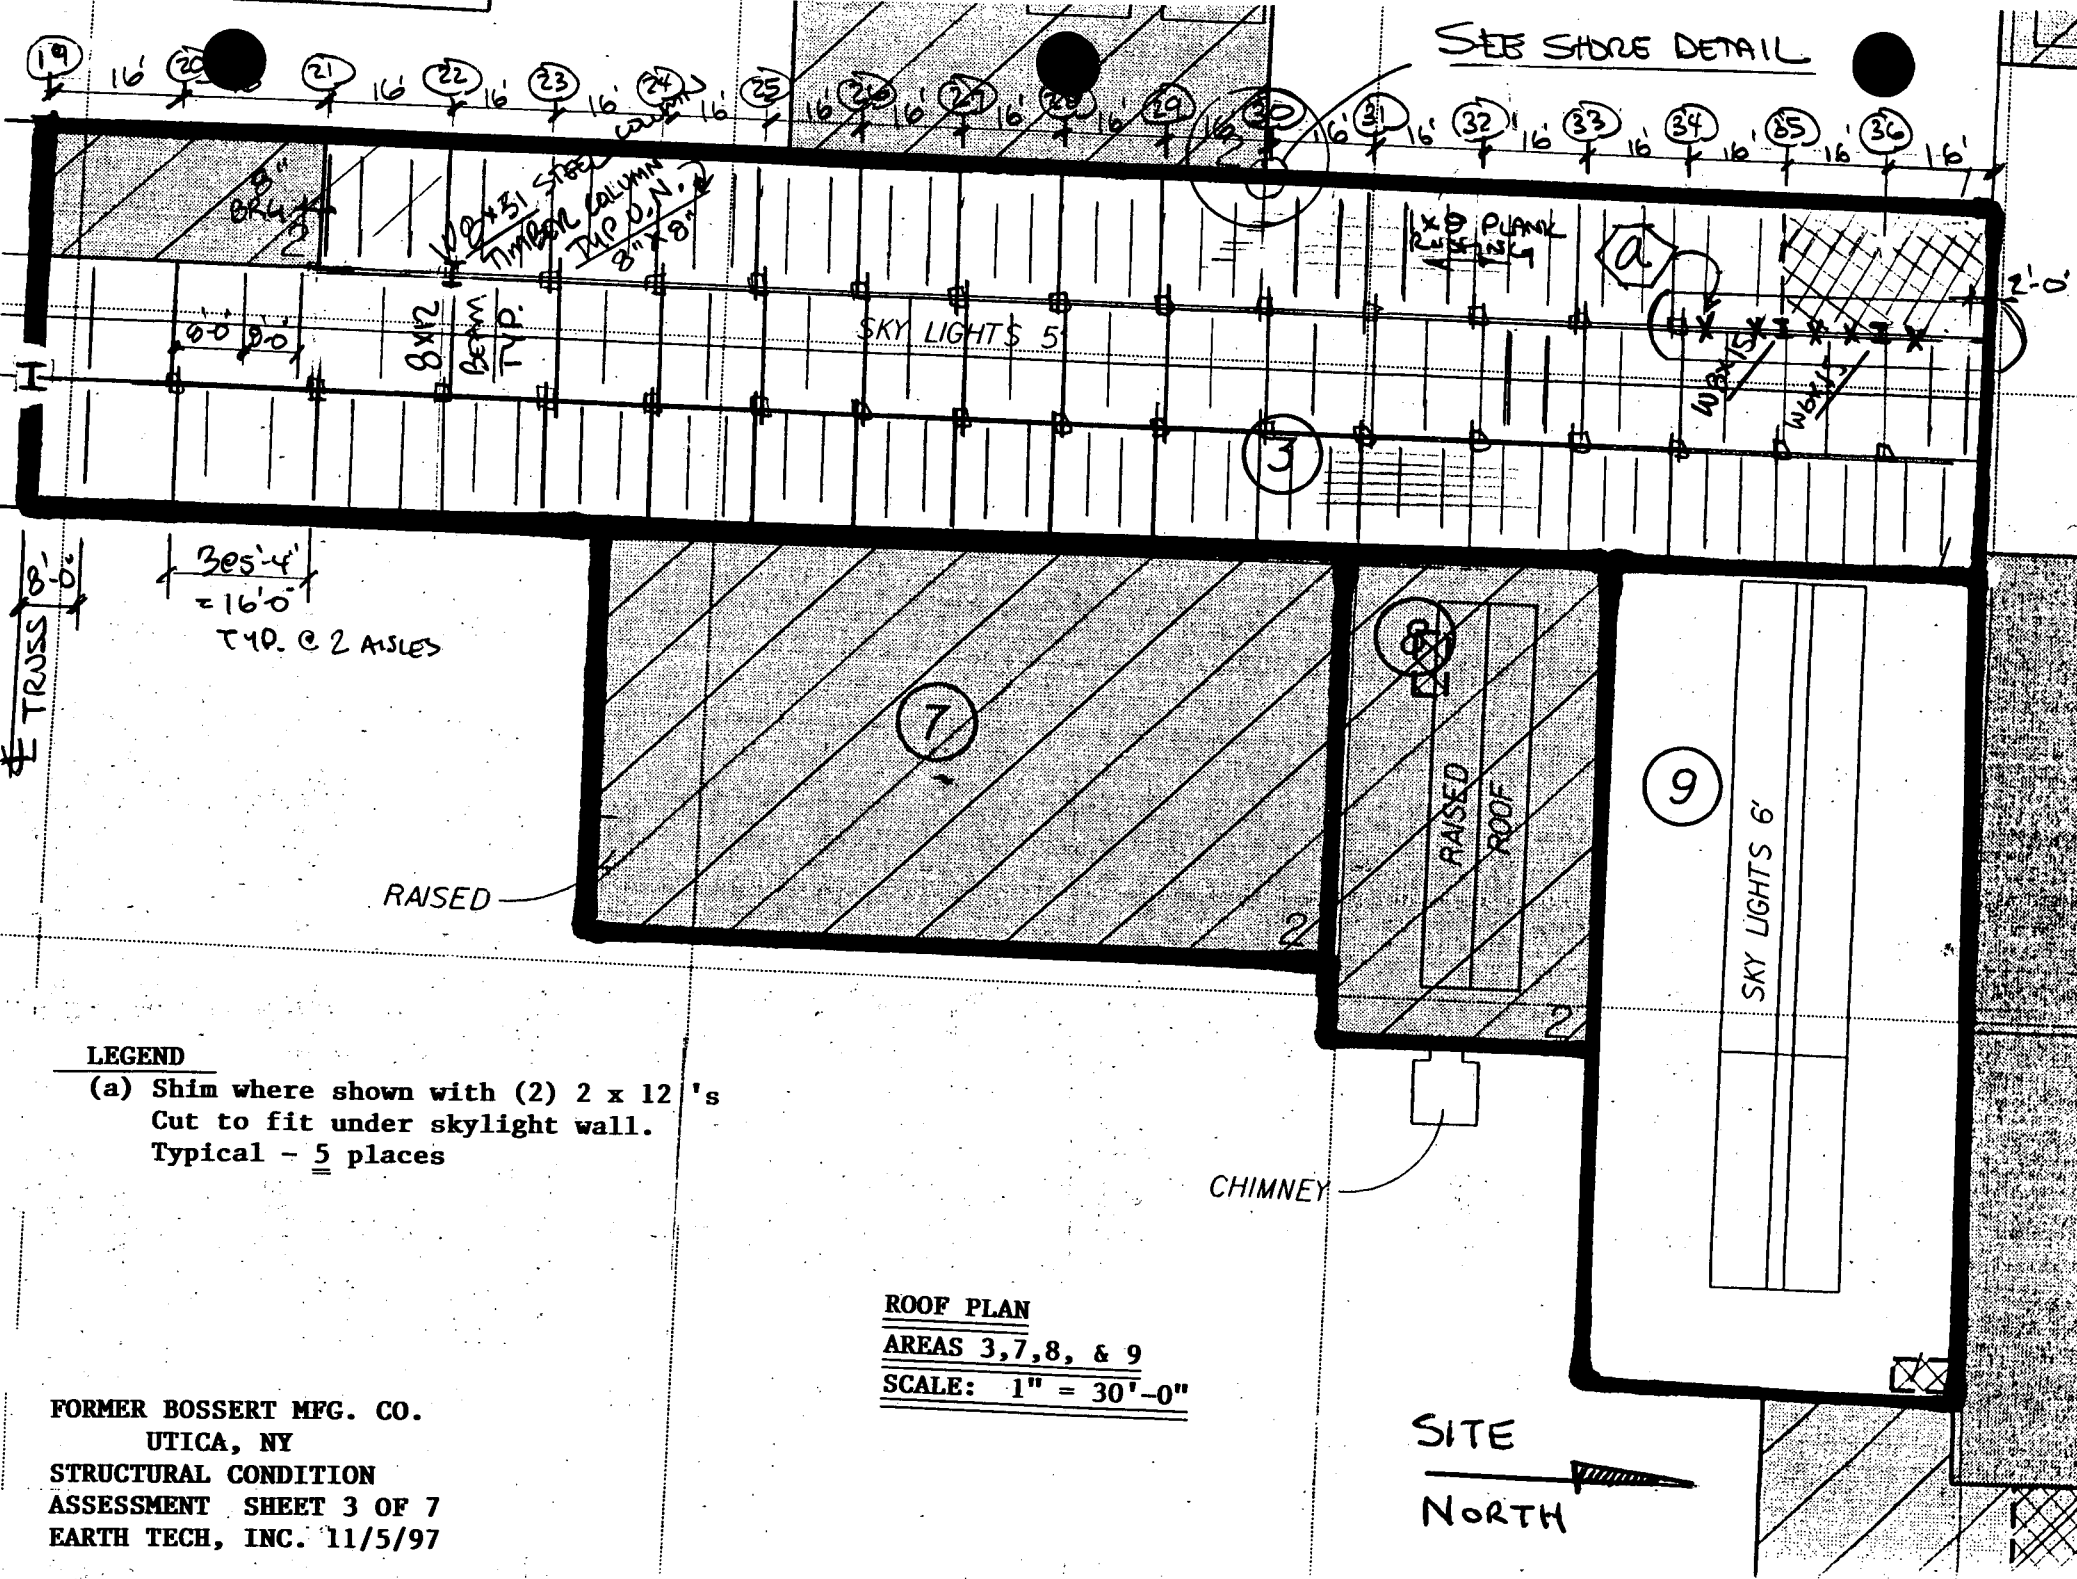
ROOF PLAN
AREAS 3, 7, 8, & 9
SCALE: 1" = 30'-0"

Another problem has been identified as a result of the roof collapse. The wood frame skylight, by design, was supported by the timber beams. Since the beams at the northwest end have collapsed, adequate support for the skylight walls is no longer present. The base of the skylight wall is badly twisted from its original position. As a result, it is mis-aligned when viewed from the supporting timber girder. To remedy this, braces and shims must be added as shown in Detail 4 - APPENDIX. As described on the sketch, the demolition sequence must be carefully followed to ensure stability and re-alignment of the skylight walls.

- (a) Shim where shown with (2) 2 x 12 's
Cut to fit under skylight wall.
Typical - 5 places

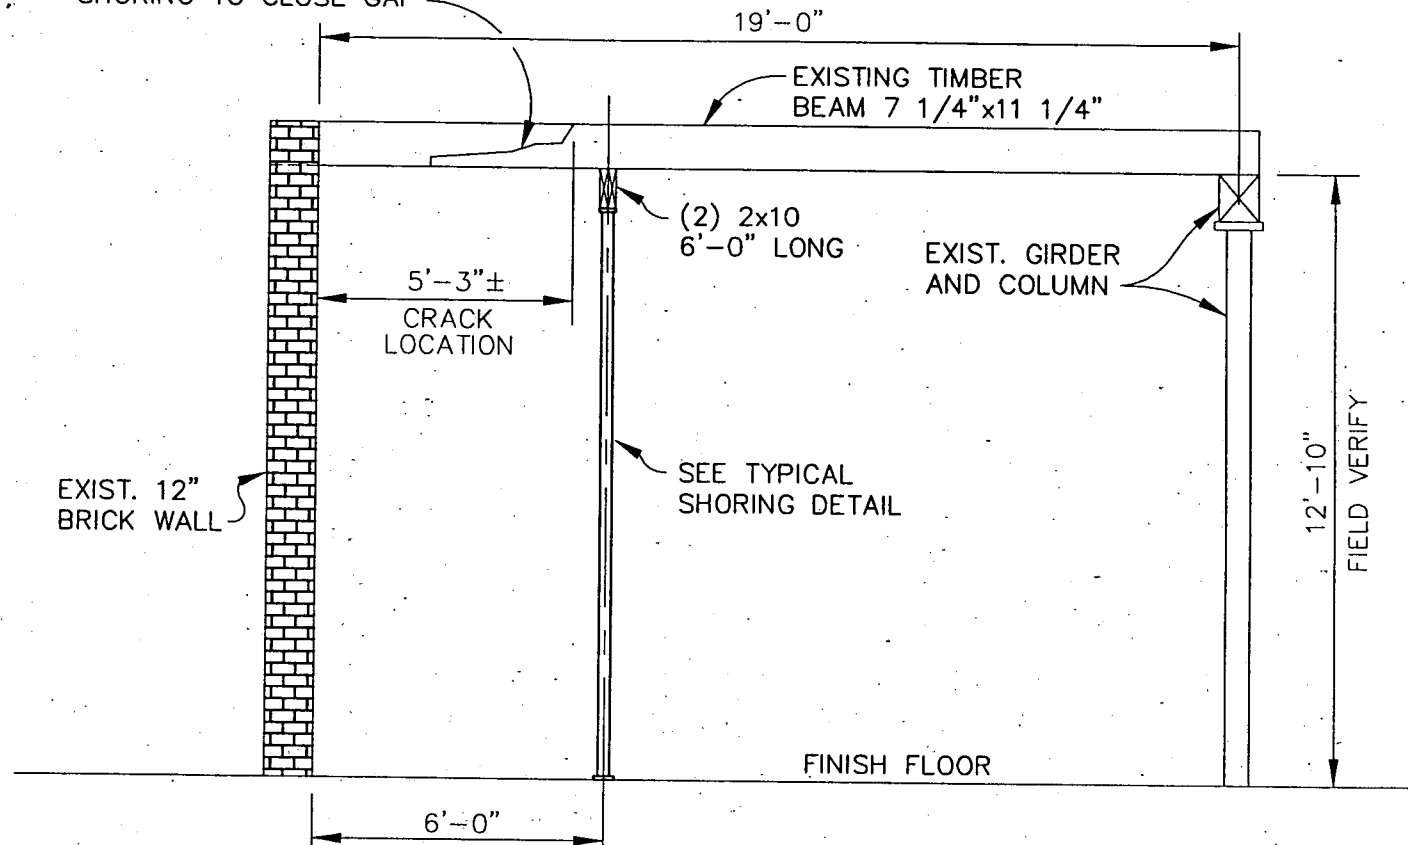
AREA 3-BUILDING ELEVATION LOOKING NORTH

It is Earth Tech's opinion that the cause of roof collapse at the northwest corner is due to failure in a connection of the prefabricated timber beam. A "hinge" developed in at least one timber beam at the "ship-lap" connection located approximately three (3) feet from the west end. The hinge is presumably caused by fatigue and resultant joint separation and failure at this ship-lap connection. Evidence of additional timber beams with the same connection problems has been found. A single bolt vertically placed in the joint further identifies this connection. These beams should be shored near the ship-lap joint as shown in Detail 3 - APPENDIX.

EXIST. TIMBER BEAM
IS SEPARATED, INSTALL
SHORING TO CLOSE GAP

NOTE:
SHORING MUST BE INSTALLED
ON EAST SIDE OF VERTICAL
CRACK

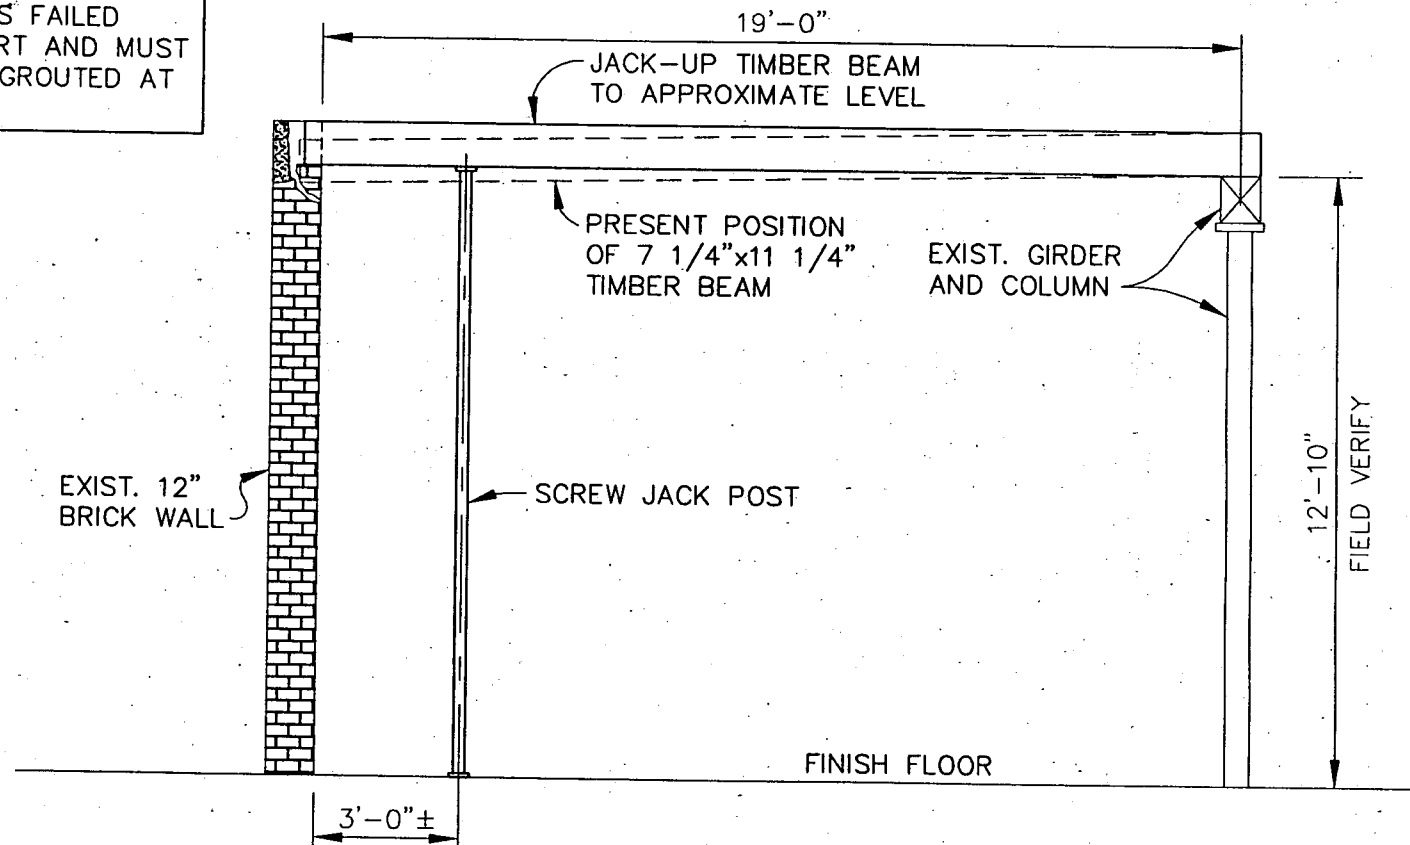
**AREA 3-BUILDING ELEVATION
LOOKING NORTH**

The 12" brick bearing walls are in relatively poor condition especially where excessive moisture is evident. This is due to continued "wash-out" of the cement mortar between the brick. In some instances this has caused bricks to displace inward. At least one (1) timber beam no longer has adequate bearing on the supporting brick. Grout is required to fill the void around the timber beam(s) - See Detail 2 - APPENDIX.

TIMBER BEAM HAS FAILED
AT BRICK SUPPORT AND MUST
BE JACKED AND GROUTED AT
BRICK WALL

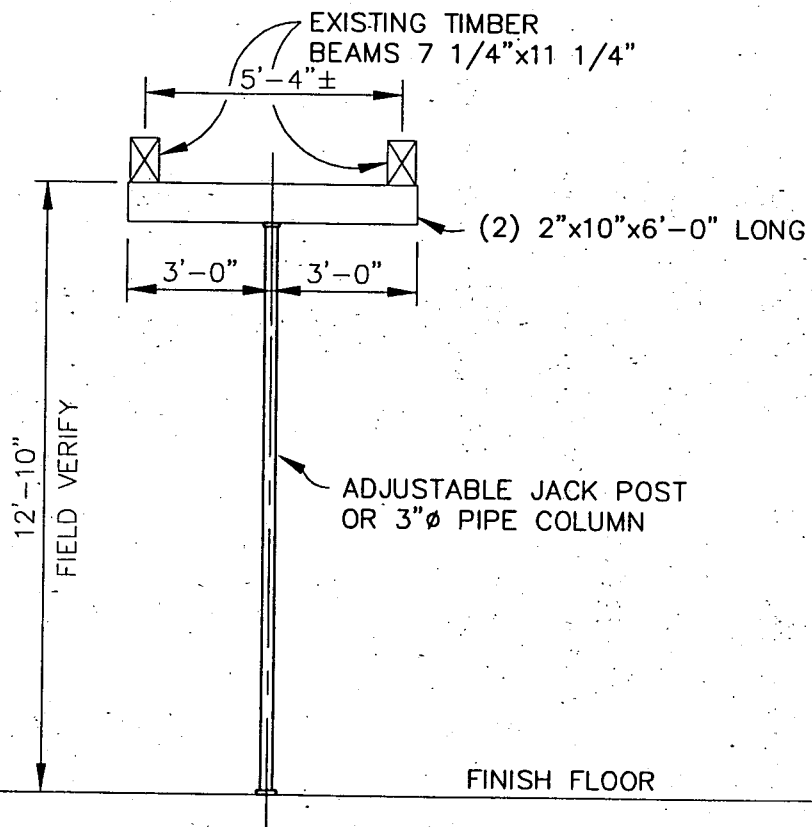
AREA 3-TYPICAL SHORING DETAIL AT WOOD BEAMS

NOTE:
SHORING MUST BE INSTALLED
ON EAST SIDE OF VERTICAL
CRACK

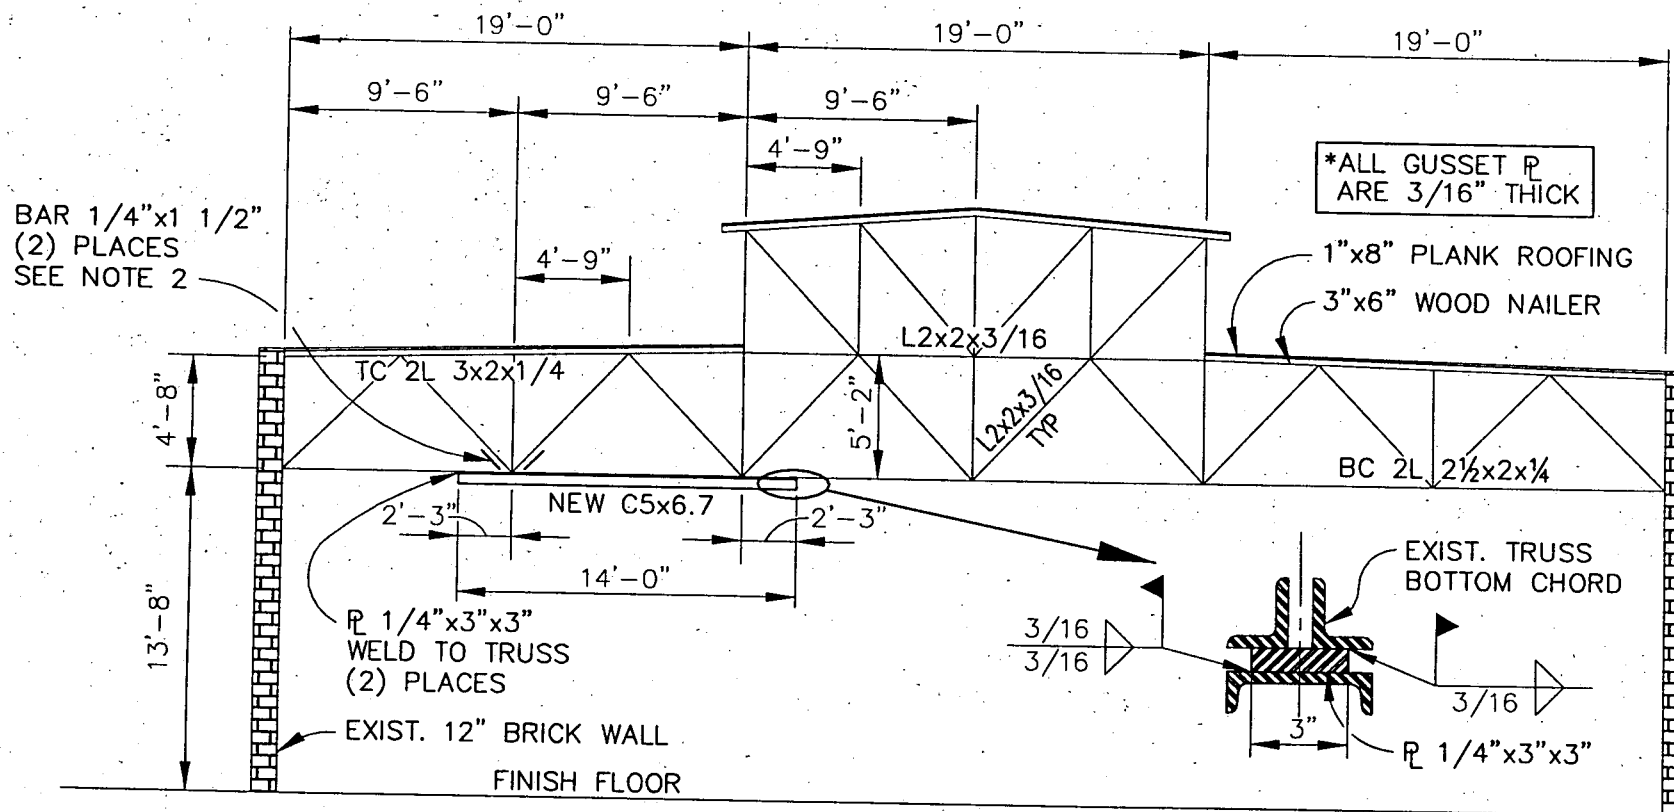
AREA 2-BUILDING ELEVATION LOOKING SOUTH

The 12" brick bearing walls are in generally good condition and support the ends of the steel trusses. The ends of the trusses are fully embedded in the brick masonry with no evidence of loose brick surrounding the truss ends. The overall appearance of the trusses show that they are well constructed and have less than 10% material loss at any cross-section. There are exceptions. Two (2) trusses exist with a missing lower chord member, obviously due to intentional cutting and removal likely at a time when the plant was operational. Specifically, the lower chord double angle $2L2\frac{1}{2} \times 2 \times \frac{1}{4}$ was removed and a gusset was severely damaged as shown on sketch Detail 1 of the APPENDIX.

An analysis of the truss indicates that the missing member is needed to transfer the "tension force" to the remaining members between lower chord panel points. A calculated tension load of 36 kips in this member is due to combined dead and snow load. A replacement member is required to be field welded at the two (2) affected trusses.

1. CLEAN ALL SCALE FROM SURFACES PRIOR TO WELDING
2. PLACE 1/4"x1 1/2" BARS ON TRUSS ONLY
3. E70XX ELECTRODES
4. A36 STEEL

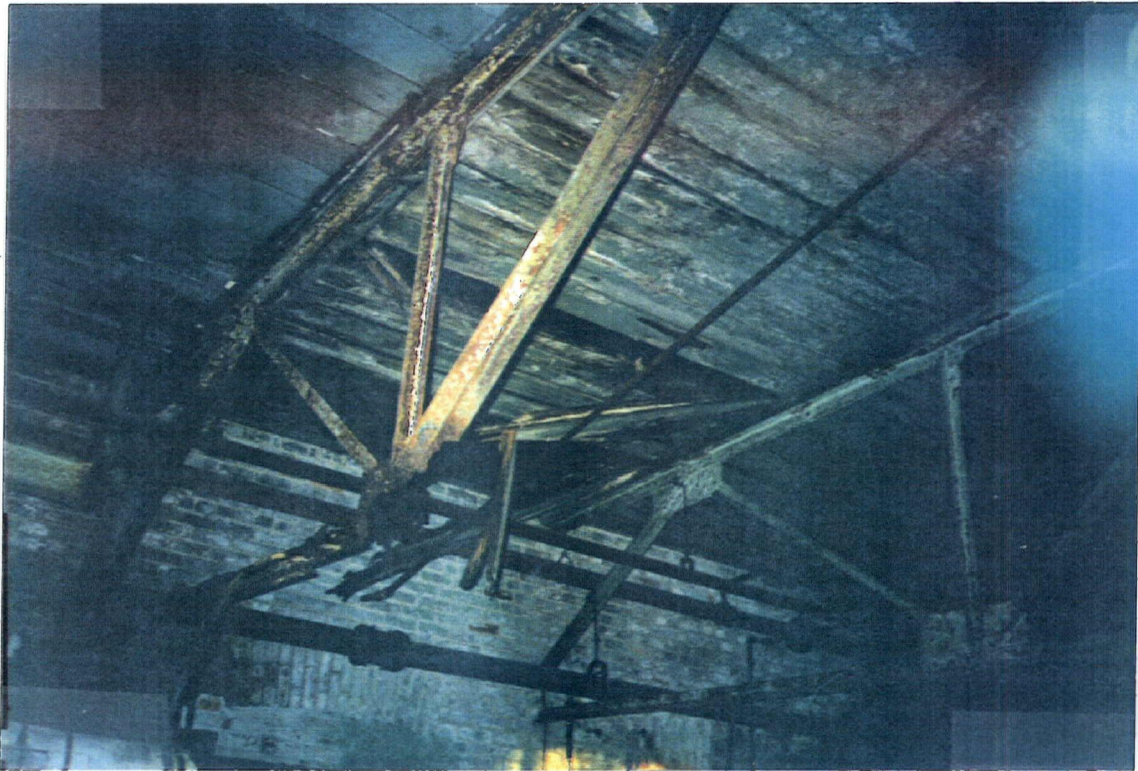
AREA 2 **STEEL TRUSS HAS MISSING LOWER
CHORD MEMBER AND DAMAGE TO
PANEL POINT GUSSET**

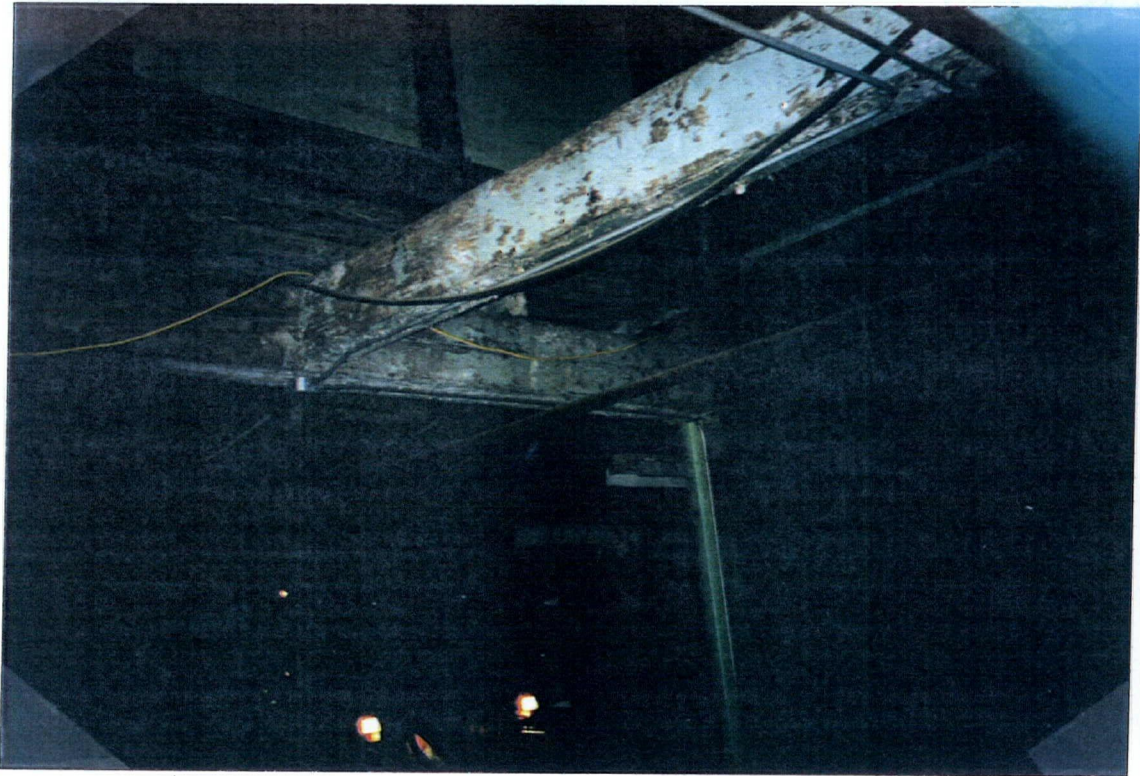
AREA 3 **CENTER "AISLE" TIMBER BEAM FRAMING
TO TIMBER GIRDER. AREA 2 IS TO THE
SOUTH (RIGHT) OF THE W6x15 COLUMN**

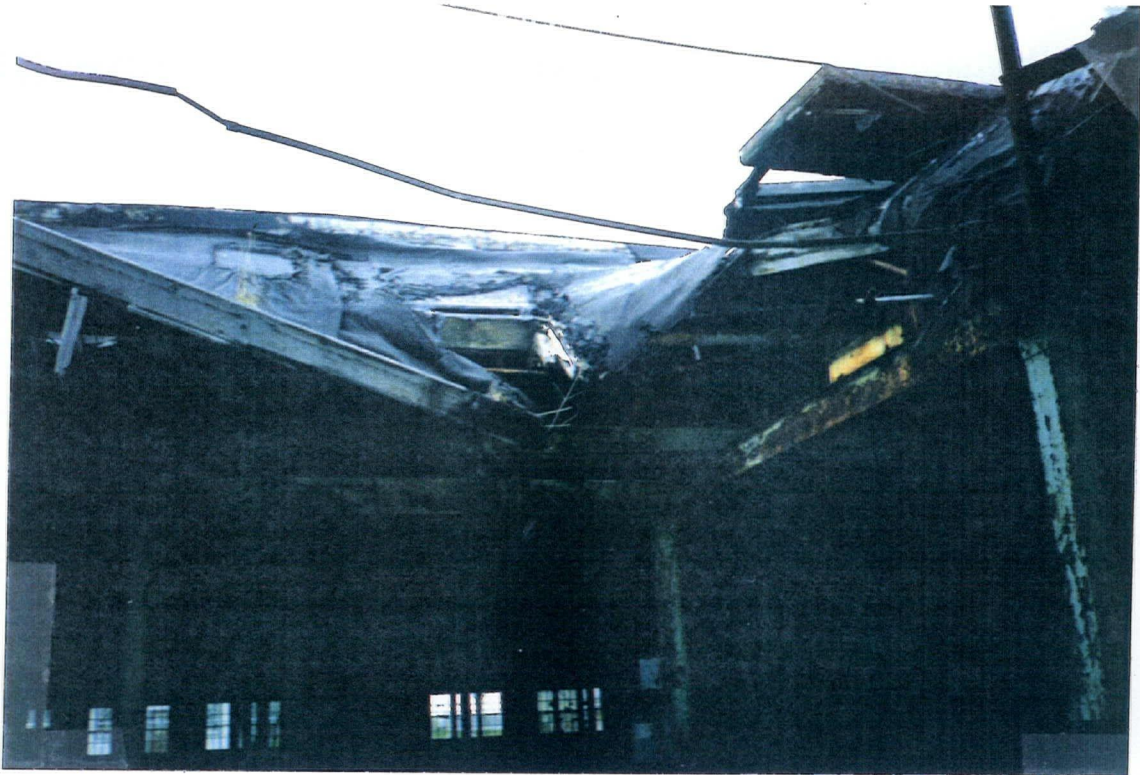
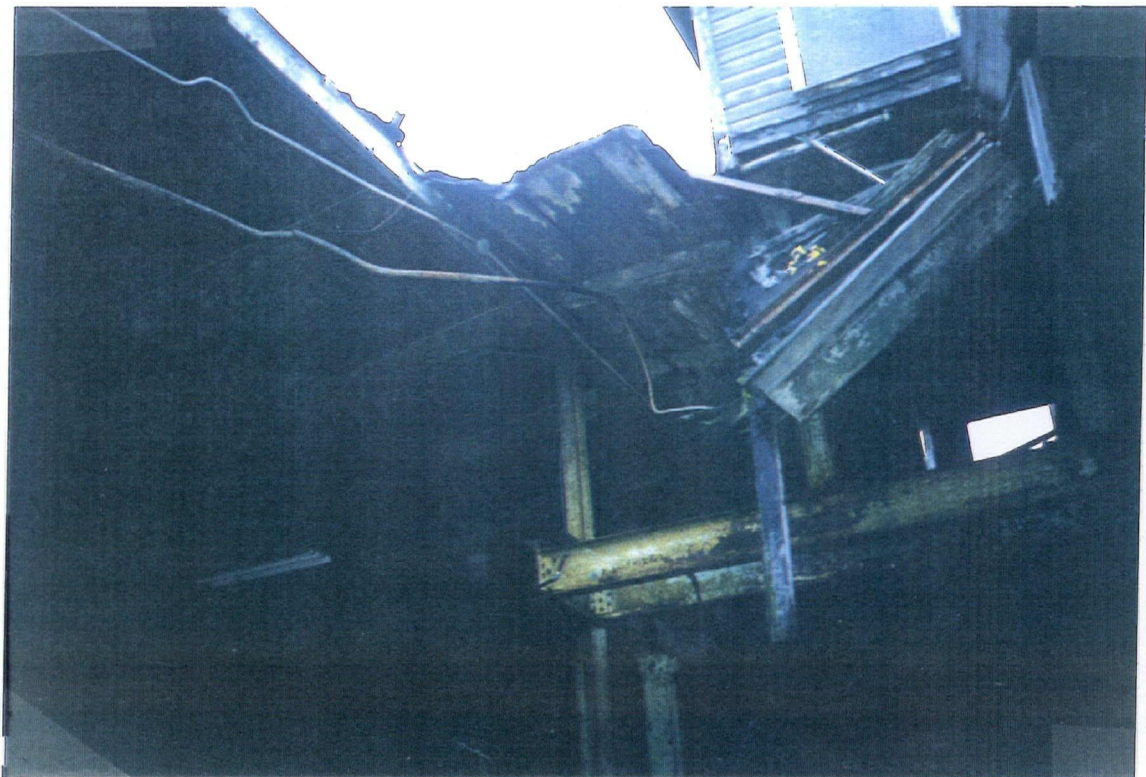
Some additional serious problems exist in **Area 12**. As a result of the roof collapse at the northeast corner, a steel pipe column has evidence of buckling but continues to support roof load. This area around the roof collapse should be roped off to protect workers near the unstable roof. The pipe column supports multiple steel members as shown in Detail 6-APPENDIX. Since the pipe column is seriously out of plumb, it is doubtful that the capacity of the column will be adequate for the applied loading.

AREA 12 ROOF COLLAPSE. ADDITIONAL INSPECTION
AND SUBSEQUENT REINFORCING IS PENDING

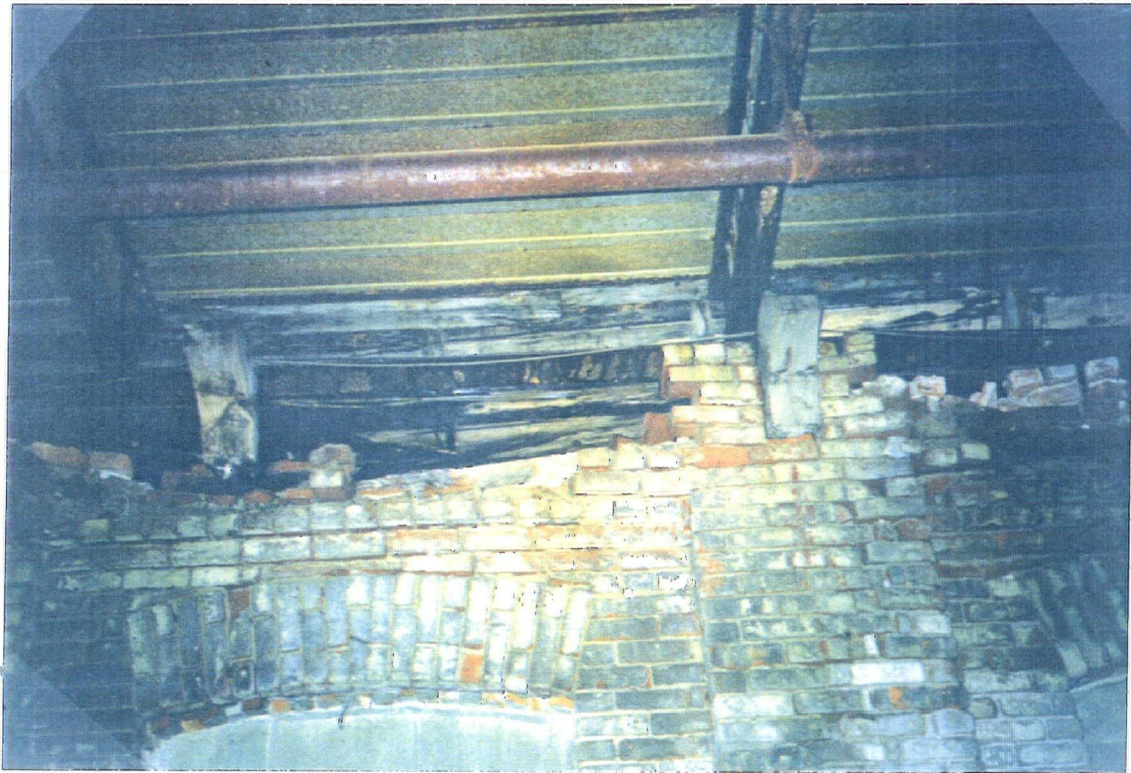
The 12" brick bearing walls of the east wall are badly deteriorated. Inspection of this wall revealed loose brick and an exposed continuous steel bearing plate that is attached to the underside of the roof "I" beam framing. This condition is best described in the photographs found at the end of the report. It is important to note that the steel "I" beams are closely spaced and welded to the continuous bearing plate. In general, even with substantial loss of brick, no single "I" beam is likely to slip off the wall because they are welded collectively to the embedded plate. Local grouting is required per Detail 5 -

AREA 12 **BRICK WALL IN POOR CONDITION WITH
LOOSE AND MISSING BRICK. NOTE THAT
BEARING PLATE ON UNDERSIDE OF
STRUCTURAL STEEL ROOF BEAMS
IS EXPOSED**

APPENDIX to maintain adequate embedment. Continued loss of brick bearing under the plate must be monitored.
